Manhole Inspection Summary

Manhole # S33EE_039MH

Insp Date: **2/16/07 10:23 AM**

Location Address: **1300 MORTON ST**

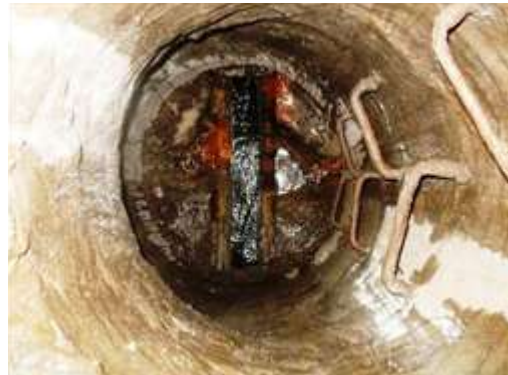
Top View

☐ Parged ☒ **Debris** (not Condition related)

Count: **6** Missing: **0** ☒ **Corroded**

Corroded steps. Bench debris.

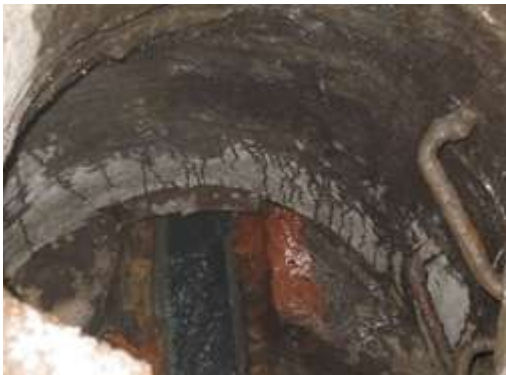
Defect

Infiltration: ☐ None ☐ Joint ☐ Cracks ☐ Mortar ☐ Roots ☒ **Wall**

Barrel infiltration.

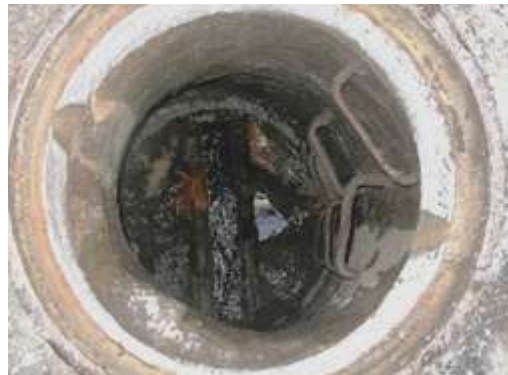
Defect

Infiltration: ☐ None ☒ **Joint** ☐ Cracks ☐ Mortar ☐ Roots ☒ **Wall**

Adjustment infiltration.

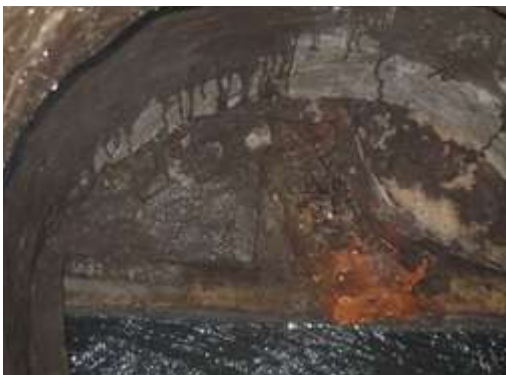
Defect

☒ **Debris** (not Condition related)

Channel and Bench debris.

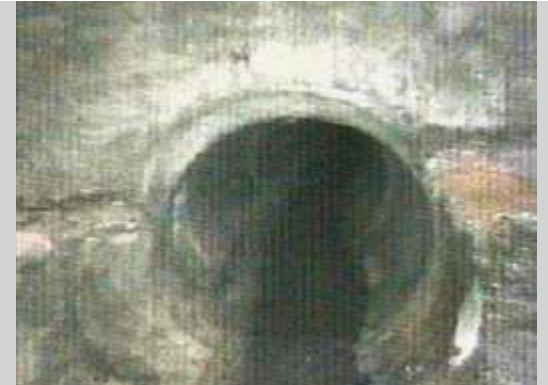
15 in. Circular Gravity Sewer Pipe Out @ 12 O'Clock

Infiltration: **Evidence** Pipe Seal Cond: **Unknown**

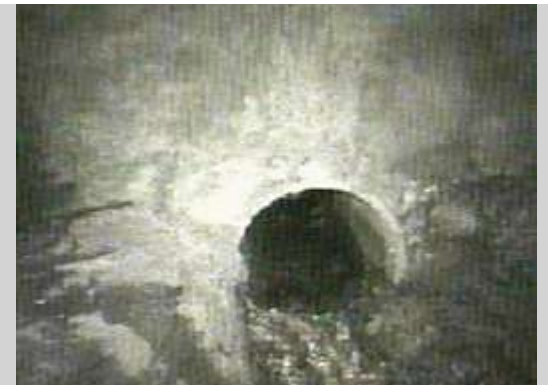
6 in. Circular Gravity Sewer Pipe In @ 3 O'Clock

Deposits: ☐ None ☒ Mud ☒ Sludge ☐ Debris ☐ Grease

Silt Depth: **1.5** (in.) Deposits Extent: **Light**

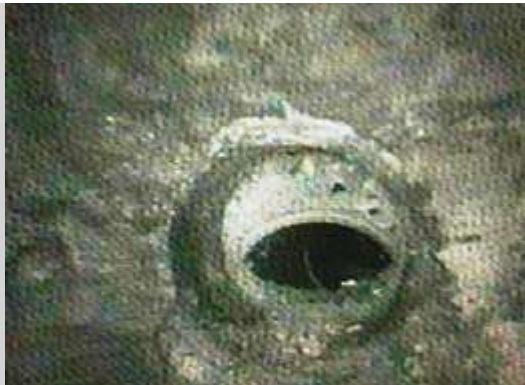
Pipe In @ 9 O'Clock

Infiltration: **Evidence** Pipe Seal Cond: **Unknown**

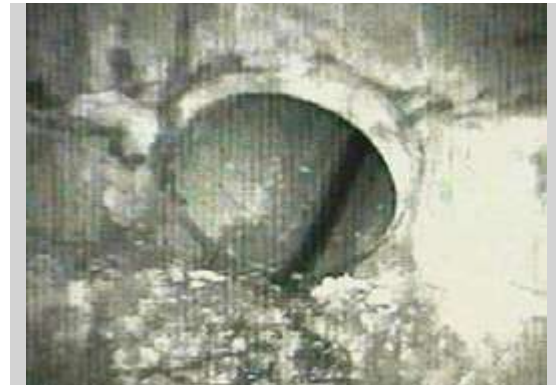
Drop In @ 9 O'Clock

Comments **The I9 pipe in has a large offset joint. This may cause the drop to eventually clog.**

Drop: **Outside** Rod and Bar
Angled: **Yes** Reading: **9.13** (ft.)
Inv Depth: **10.13** (ft.)
Drop Condition: **Open**
